# Space Borne Technology in Assessing and Monitoring Bank Line Erosion of Busu River, Lae City, Papua New Guinea.

Tingneyuc Sekac,<sup>1</sup> Sujoy Kumar Jana,<sup>2</sup> Dilip Kumar Pal<sup>3</sup>

*1,2,3 Department of Surveying and Land Study, PNG University of Technology, Private Mail Bag, Lae 411, Papua New Guinea*

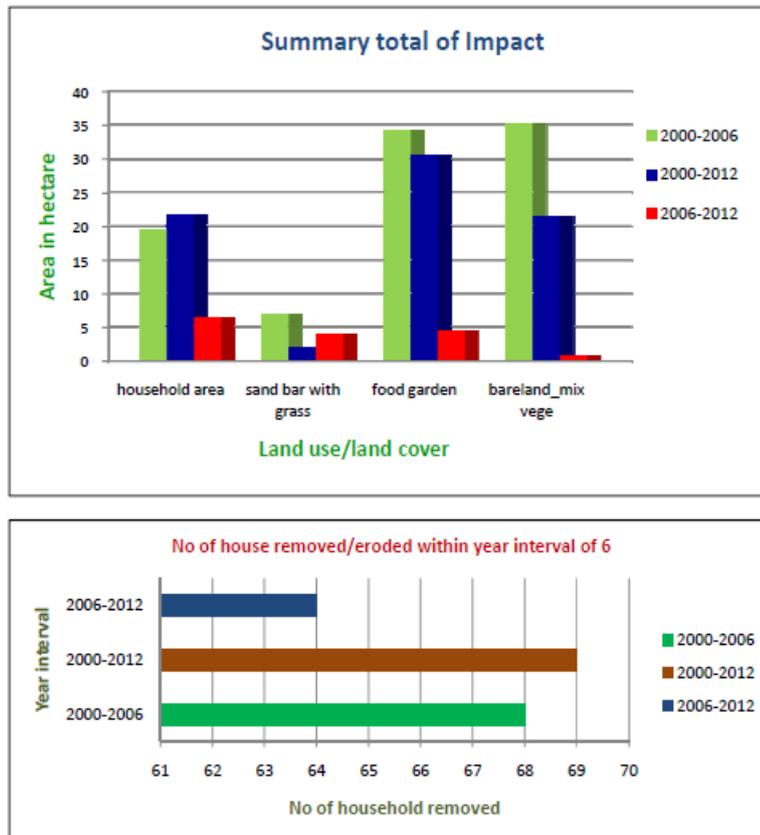
Figure 1: Summary total of impact of Busu River Course change (Source: Sekac, (2014))

Busu River is a fast flowing river in PNG. It cuts, erodes and deposits at high rate. During the field visit, the velocity of Busu River was measured and calculated to be 4.44m/sec, which indicates that the river has high velocity. From the previous study done (Sekac, 2014), with change detection technique, it was found out that huge expanse of land and huge number of households have been eroded or removed from time to time. Figure 1 illustrates the impact caused by Busu River channel migration and shift from year 2000 to 2012. It was the overall assessment for whole Busu River, starting from Busu Bridge all the way down to the sea.

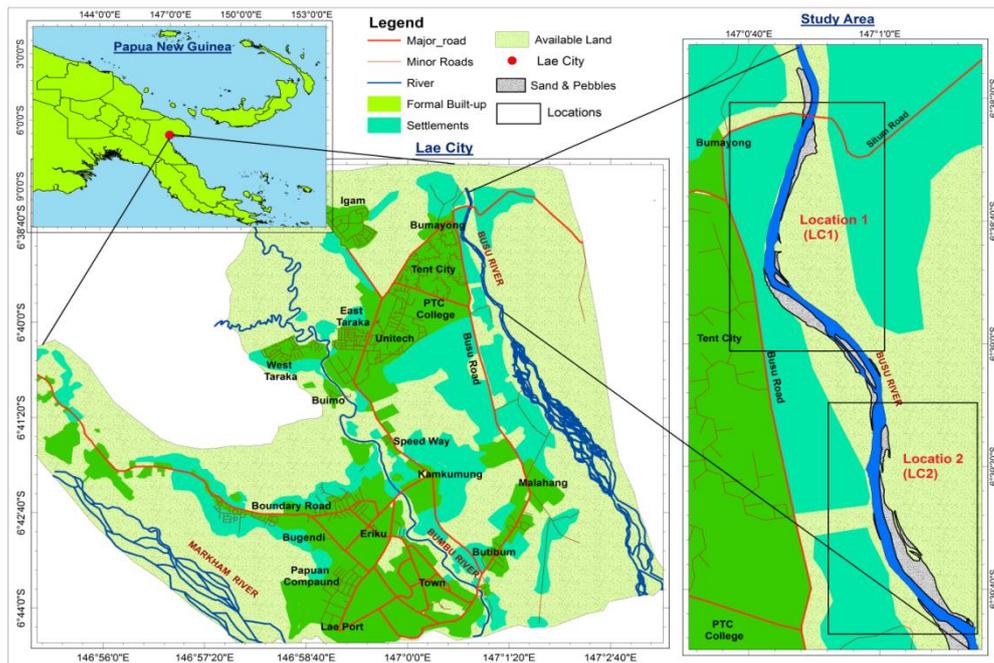
Figure 2: Study area locality map (source: Author, 2016)

Within the current study area, it can be seen from the locality map (figure 2) that the Busu River is eroding and heading towards city zones where more infrastructure, households and available land are to be removed or eroded (affirmation from experience). It is from the experience that, there has been water ways created to divert or change the river course so that the river can't head towards city zones, however due to existence or available of hard rock within the study region, it is practically impossible to divert the river in order to save the city zones from attrition. Hence currently the river is still eating away the bank line towards city zones.

The study area is located within Lae city, the second largest industrialized city in Papua New Guinea (PNG). As far as three major rivers are concerned that exist within Lae city, the study was only carried out at upper meander stream of Busu River that flows South-East direction and is about three (3) kilometres in length and hence located between 60 38'20 S, 6039'40S and 1470 0'40E, 1470 1'00E. The study was fully concentrated on these sites as mentioned because the sites are more vulnerable for erosion and bank cutting, where the researchers have previously experienced up to present. Also the sites have been selected for study because the gateway of direction of erosion and bank cutting, as it can be seen it figure 2, are towards or into city zones which is dangerous. Therefore the sites selected for study is

important here. The study area has been again divided into indicating sites 1 and 2 or location 1 (LC1) and location 2 (LC2) for precise analysis and assessment.

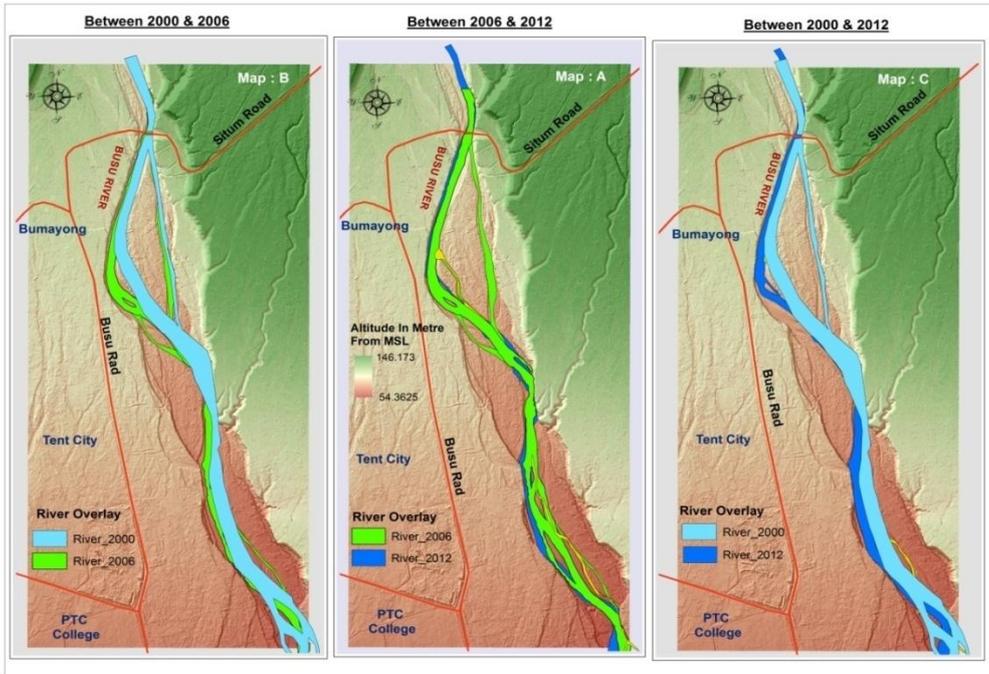
Figure 3: Busu River shift between years (source: Author, 2016)

Firstly the year 2000 and 2006 river vector data were overlaid and the river shift and properties or area eroded were evaluated between each cross-sections of each location. The same technique was applied to evaluate for year 2006 to 2012. Finally the combined impact or effect analysis was carried out for year 2000 up to year 2012. From the findings of the river shift and impact imposed, the data were used to do prediction between each cross-section for each location. The prediction technique employed was the interpolation techniques adopted from Das et al. (2012). Figure 3 illustrates the overlay analysis and the changes of river taken place between each year.

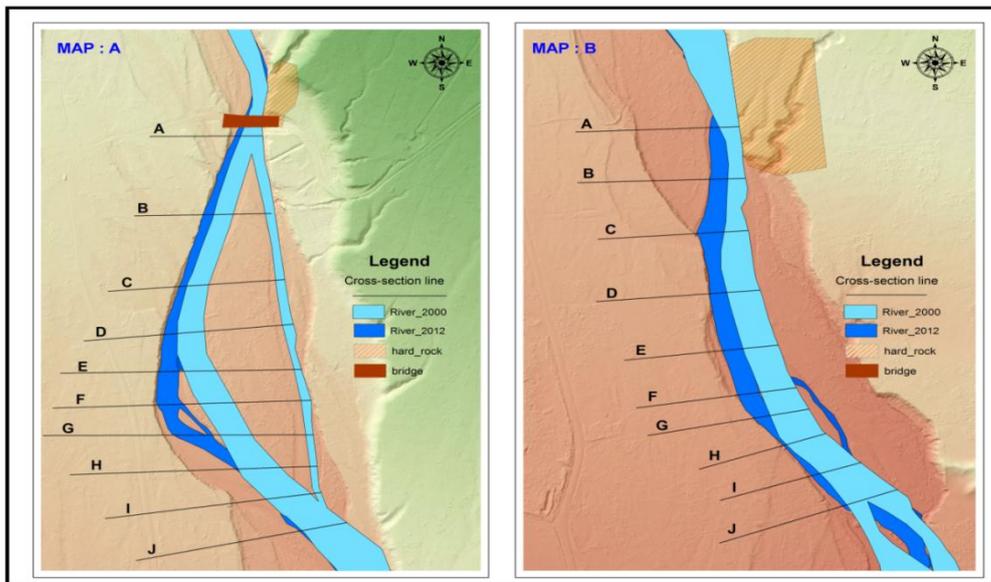
Figure 4: Cross-Section lines drawn to measure river shift and impact (Map A-LC 1 & Map B-LC 2) (source: Author, 2016)

To further the analysis part into measuring and calculating the river shift, bank lines erosion or cuttings, number of household, infrastructure or properties removed and to predict the future shift or position of Busu River, the number of 10 transect/cross-section line named from 'A' to 'J' were drawn across the river for both LC1 and LC 2 (figure 4). This technique was applied simply to calculate impact and rate of river shift or change between each cross-section (Thakur et al, 2011) where it can easily assist in doing prediction of future position of river (Das et al. 2012; Nguyen et al. 2010; Laha & Bandyapadhyay, 2013). Field visit and local interview data taken were also used to verify and help in calculation of impacts and finding out possible cause and source of bank line erosion. The calculation and findings were done location wise and cross-section wise.

The climatic condition of PNG is wet and dry and during wet period with heavy down pour, the river floods. Every time as the river floods, the bank lines at LC 1 in the south-westerly direction to the meander sites (Figure 4&5), are always eroded and cut (from researcher point of view) approaching into the Lae city inter zones.

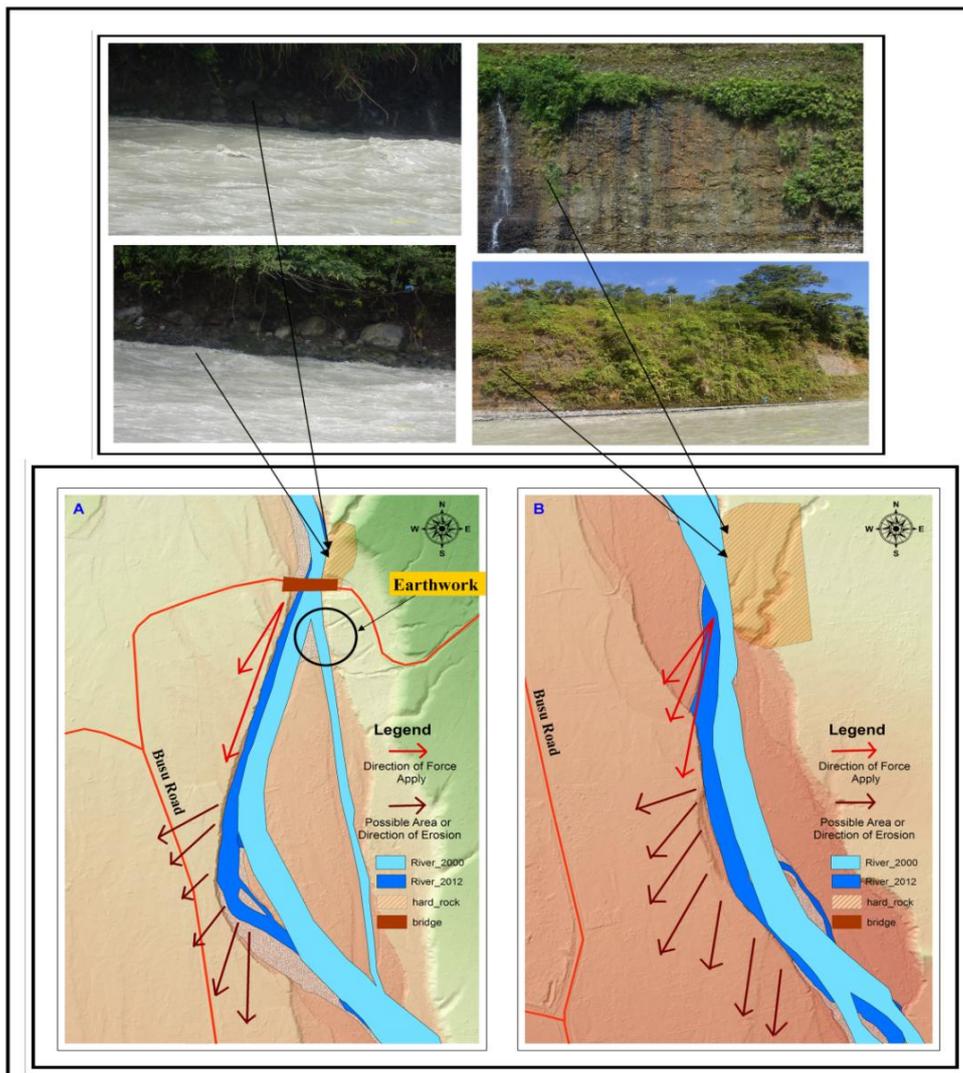
Figure 5: Possible direction of river force and erosion (Map A-LC1 & Map B-LC2)  
(Source: Author, 2016)

From the past to present, Buss River has cut/eroded huge amount of land masses, household and food gardens. One of the researchers, who is also a victim of Busu River bank line erosion, societal impact have been analysed and from his point of view for about 20 years' time period, have discovered significant knowledge and idea on behaviour and characteristics of Busu River flowing system. By involving the space borne technology within GIS environment, the changes of Busu River channel shift were identified from time to time (figure 3). For LC 1, it was found out from time to time that the river directions of force were always and possibly to the south-westerly direction, there the possible bank line erosion normally occurs exactly where the meandering patterns exist. For LC1, it was identified through field visit and also with remote sensing data, that there exists a huge hard rock in the north-east part of study area right at where another meandering river pattern exists above Busu bridge (figure 4&5). It was quantified that this is the hard rock where river hits and gain strength (increase velocity) that causes aggravated erosion at the backline south-westerly of LC 1 river bank.

For LC2 there have been massive bank line erosion and cutting that have occurred from time to time up to present. Form the actual field visit and from researcher experience and point of view with the assist of remote sensing data, the possible areas and direction of erosion were identified and mapped. It was found out that, due to existence of hard rock in the north-eastern part of study region at LC 2 where the meander pattern exist, the river does hit and acquire pressure and force (increase velocity), where this result in high velocity that cuts and erodes and curve the bank line in the west and south-westerly direction thus leading into Lae city inter zones. Figure 5 (B) illustrates the findings, quantification and affirmation of possible direction of river force and erosion with demarcation of hard rock.

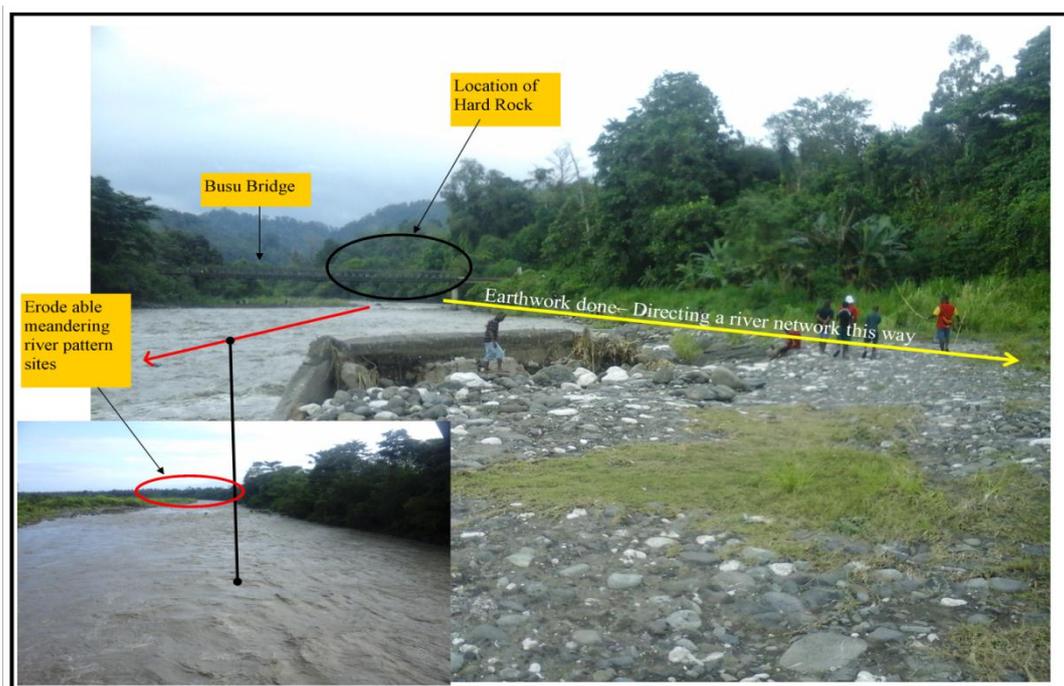
Figure 6: Flowing direction at Location-1(source: Author, 2016)

By taking this into consideration, there have been dredging or earth working took place between year 2005 and 2006 to change the course of Busu river to lead to the south-easterly direction (figure 6) where the paleo channel was found for year 2000 image. However due to the presence of hard rock, the result of work done was negative and currently the river is still flowing and eroding in the south-west part of LC 1 within and around the meander sites (figure 4& 5). Thus at the meander part where the river is currently exacting pressure, there is no existence of any hard rock. The soils out there are soft and loose mix with sand and pebbles that makes sites more prone for erosion. Figure 5 (A) illustrates the findings, quantification and affirmation of possible direction or force of present river flowing system including possible area of erosion. Also the figure illustrate where the hard rock was identified for LC1. Figure 6 illustrates the current river flowing pattern at LC1.

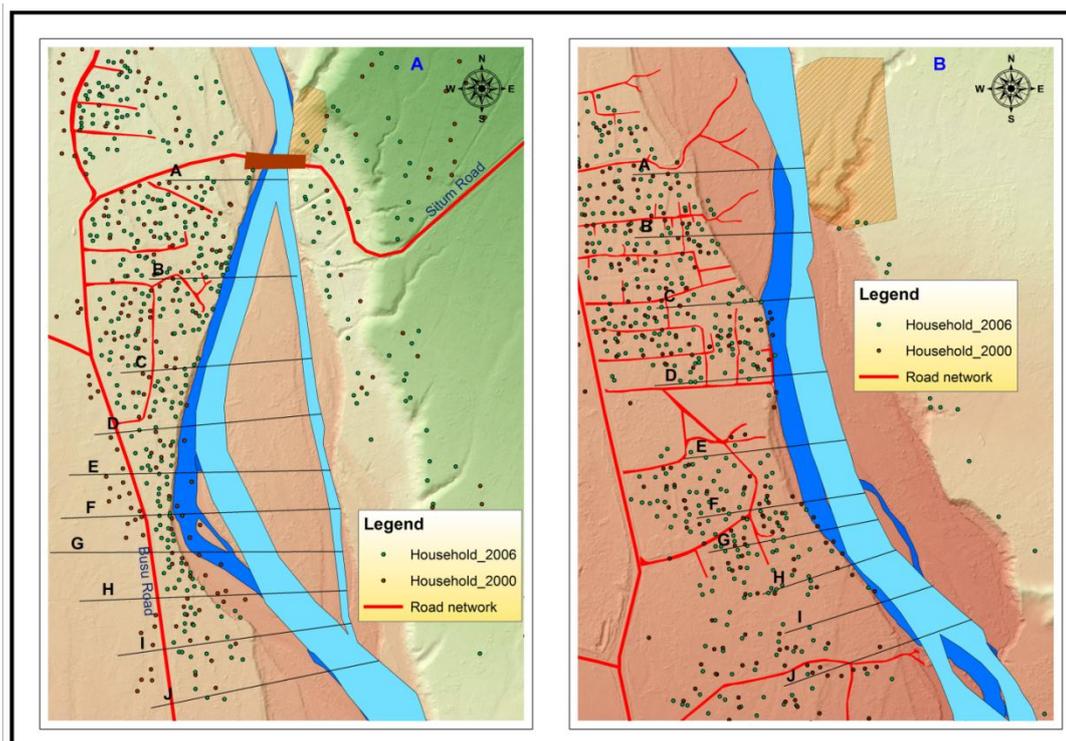
Figure 7: River Shift and impact between year 2000 & 2012(source: Author, 2016)

From each cross-section line as were discussed earlier, the river shifts between each year were measured for both LC1 and LC2 and between each cross-section line, the amount of land masses removed and the number of household eroded or removed were measured. The main idea here in impact assessment is simply to find out how much in metre the river has shifted towards city zones from time to time and to find out how much in square metre the river have eroded the bank line from time to time. Also the task has been to find out the number of households that were removed or eroded from time to time. The analyses done and the findings/results are all presented in graphs and charts below. Figure 7 ‘A’ and ‘B’ illustrate the actual map of river shift in metre and its impact. Figure 8 illustrates the graphs prepared to highlight shift in metre between each time interval for both locations (LC1 & LC2). It was measured with respect to each cross-section line. Figure 9 illustrates the findings of impact based on amount of landmass eroded/removed and number of household remove due to river shift between time to time. Figure 10 illustrates the actual current images taken to highlight the areas of impacts. The analysis and findings here were used for predicting the next shift or possible location of Busu River.

From the analysis and evaluation as discussed above, the necessary results were generated (figure 7, 8, 9). Hence the data were then used to carry out certain analysis and calculations to demarcate the future shift and location of Busu River. Also to point out amount of landmass and properties that can be possibly eroded and removed. Simply extrapolation method with intense calculation was applied to find out possible shift in metre of river. The river shift data for year 2000 was extracted and measured compared with 2006 and 2012; there the calculation was done collaboratively between each time interval to point out possible location of Busu River in 2030 through 2050 years of time period. According to Das et al. (2012); Nguyen et al. (2010); Lagasse et al. (2004b) & Heo et al. (2008), the future prediction of river shift can be evaluated or possibly done through utilizing and analysing the past related data of river shift between times to time (past year interval). For the present study the extrapolation technique was employed in GIS and remote sensing environment to calculate and find the distance in metre where river is to be shifted for year 2030 and 2050. From the survey and field visit, it was found out that at both locations, the river has a tendency to shift towards city zones. Thus the prediction was done to highlight the possible areas of future erosion and bank line cuttings and possible future location of river, that is to bring to the understanding of local community and governing bodies where mitigation and awareness measure can be possibly implemented at rightful location to minimize and avoid risk. Table 2 and 3 tabulate the possible data acquired with possible calculation done.

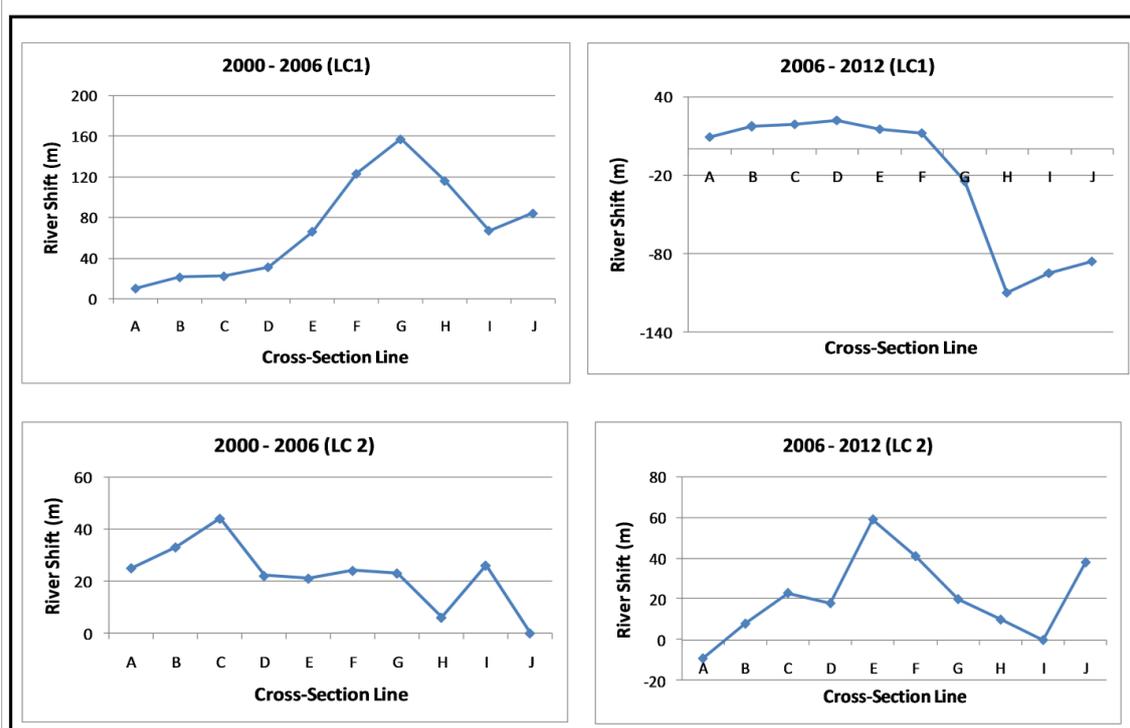
Figure 8: River shift measure in metre (m) at each cross-section line (source: Author, 2016)

From the analysis and evaluation the results and findings were output. For location 1 (LC1) between year 2000 and 2006, the river has much shifted in between cross-section ‘D’ up to ‘H’ (figure 8) where huge amount of land mass with its features have been removed or eroded (figure 9). Between cross-sections ‘A’ to ‘D’, the river shifts have maintained at minimum steady rate as it can be seen in figure 8. The bank line or areas between cross-section lines ‘D’ and ‘H’ are said to be highly prone for erosion during flood. Consequently between 2006

and 2012 for LC1, beginning from cross-section ‘F’ all the way to ‘J’, there has been deposition taken place, where it is believed that currently the river force is directly applied at the bank line between cross-sections ‘C’ down to ‘E’. However from cross-section ‘A’ to ‘F’ the river shift maintain at minimum where erosion or bank cutting is minimum. From figure 8 and 9, it can be seen that the graphs highlights the negative values, thus this gives the idea that the river has shifted away from bank line and hence resulted in huge deposition (figure 7). For LC1 from year 2000 all the way to 2012, there has been quite a substantial number of households removed at the sites indicated between cross-section line ‘A’ to ‘B’ and ‘D’ to ‘H’.

For LC2 from year 2000 to 2006, the distance of river shift maintained below 50m and the changes across or between cross-section lines maintained no proper trend, thus it is changeable from cross-section to cross-section. The maximum amount of bank line erosion took place were from cross-section ‘B’ to ‘F’. From year 2006 to 2012, the river shift starts increasing from cross-section line A up to E and then again decreases down to I. The amount of erosion follows the trend of how river have shifted. It can be seen from figure 9 for LC2 that maximum erosion or bank cutting have occurred between year 2000 to 2006 where between year 2006 to 2012 the impacts were minimum. This was due to how intense were the flooding that have occurred from time to time. The bank erosion or bank cutting pattern at LC2 is curvilinear. Furthermore from year 2000 all the way to year 2012 at between cross-section line C and D there have been maximum numbers of household removed or eroded followed by loss of available land. Thus these areas are vulnerable areas of erosion.

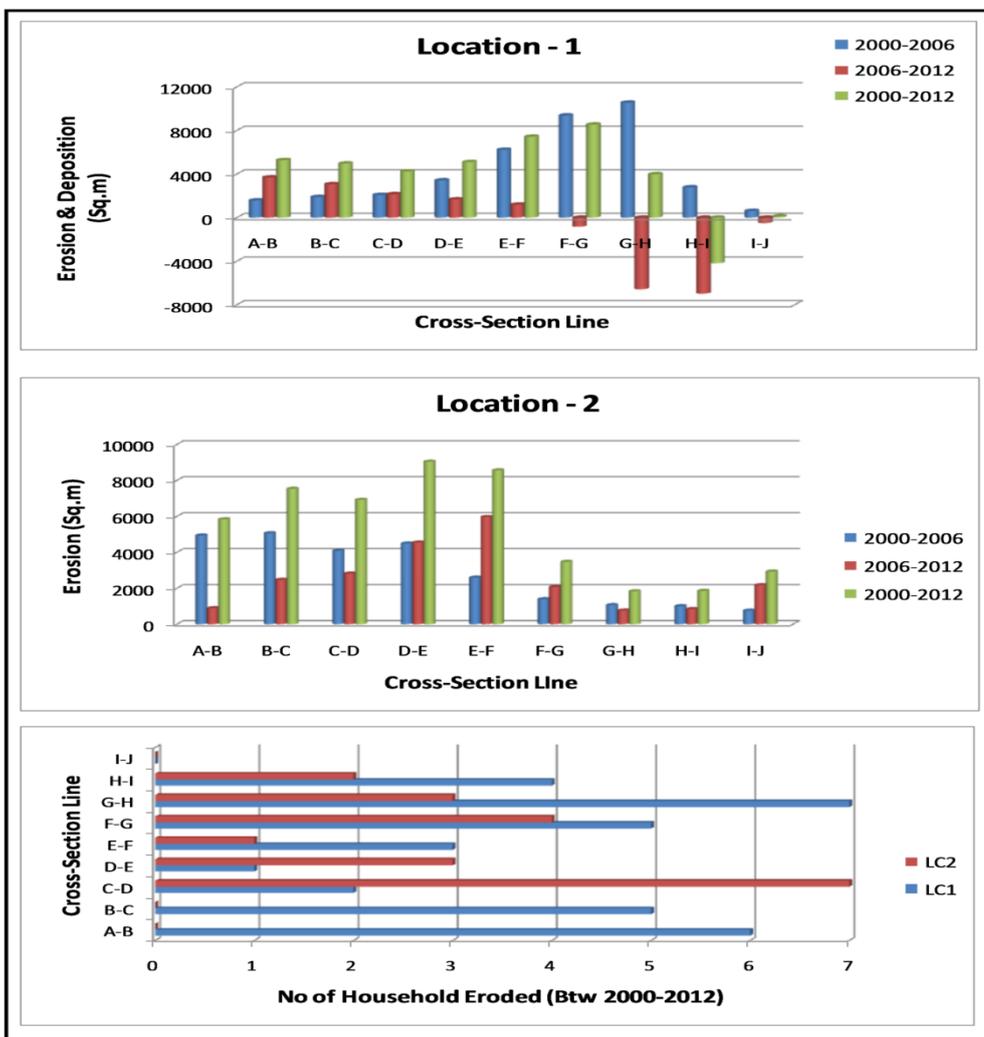
Figure 9: Impact findings between each cross-section line from time to time (source: Author, 2016)

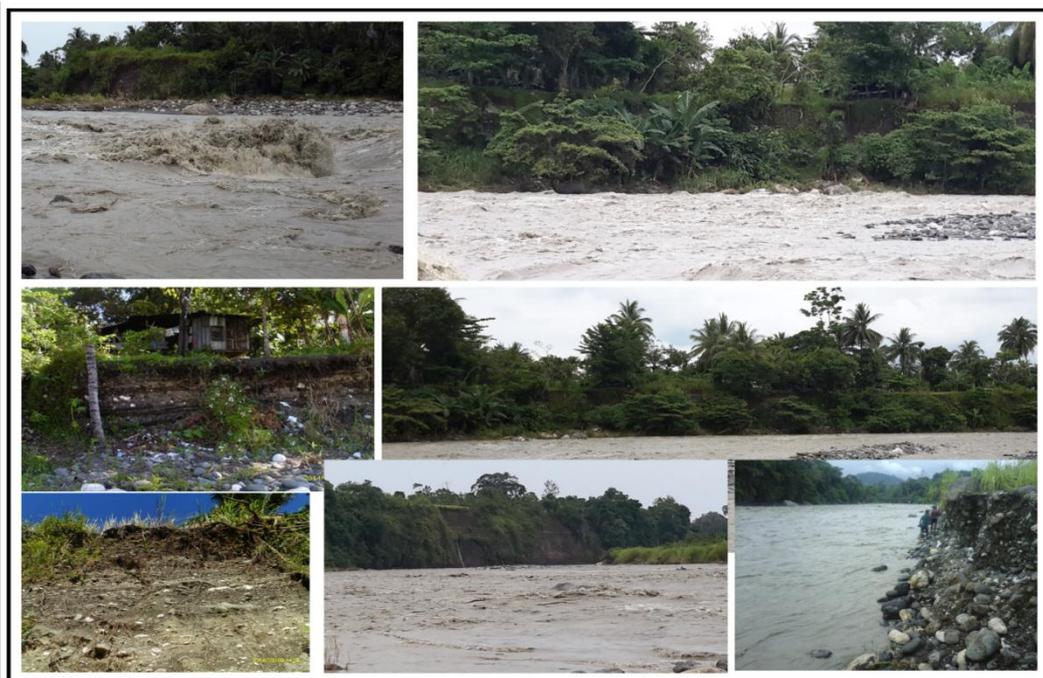
Figure 10: Images taken by Author during field visit to highlight related impact of river shift

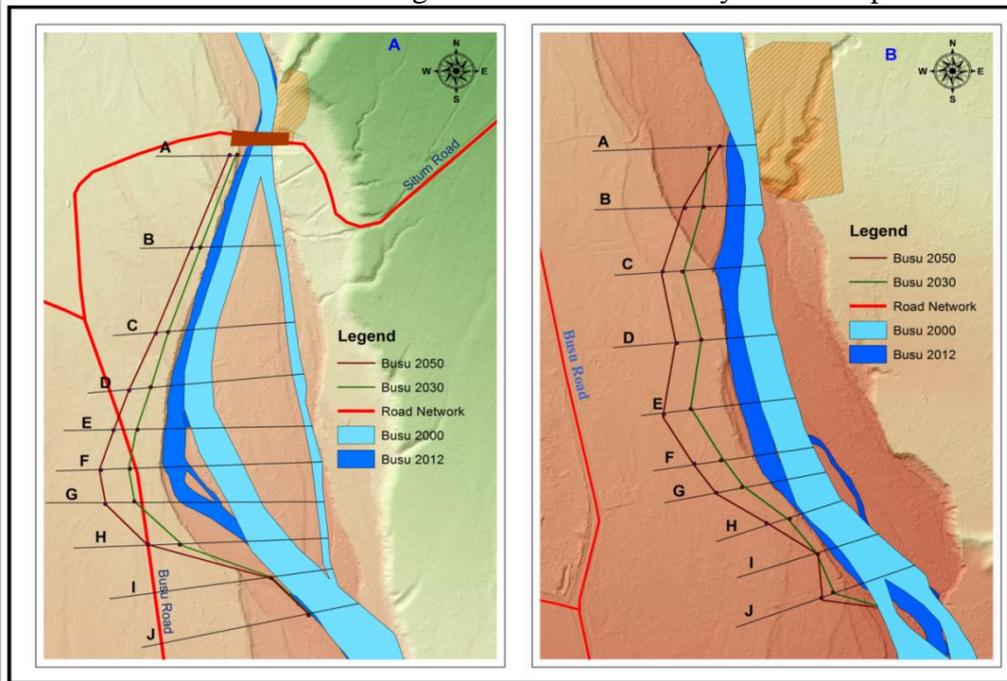
Figure 11: Prediction of River shift by 2030 and 2050 (Map A-LC1 &Map B-LC2) (source: Author, 2016)

During calculation, some values were calculated to be negative. Thus this indicates the river shift is negative. The calculated values were then integrated in GIS environment using ArcGIS tool to demarcate the shift measure. Mainly the base data used was for year between 2000 and 2006. The subtraction was done between data for 2 years' time period and then was multiplied by year difference and again added to the base data to come up to the final output for year 2030 and 2050. The calculation done and value output were all demarcated on the map. Figure 11 illustrates the demarcation and extrapolation done for both location based on the calculated values.

The map at figure 11 actually portrays the 2030 and 2050 bank line position or location of river shift; that is where it will be. It was assumed that due to high river velocity (4.44m/sec) and also due to presence of hard rocks, the river has a tendency to hit and erode the bank line towards city zones at South-West direction.

The extrapolation calculation was done to highlight future river bank line after erosion, however the erosion or bank cutting can be slow or fast depending upon amount of rain that can induce or contribute to flooding, rate of human activities along or near the river bank, levels of earthquake events where this can lead to landslide because the height of current river bank, which is measured to be roughly 10 -12 metre steeply high at LC 1 from cross-section line ‘A’ to ‘G’ and 4 -6 metre gently to steeply high at LC2 from cross-section ‘B’ to ‘I’. Thus explained here are the medium or factor that can contribute to determine rate of bank line erosion or bank line cuttings for the next 20 to 30 years’ time period.
